ILLICIT DISCHARGE DETECTION & ELIMINATION PROGRAM

AT THE US NAVAL ACADEMY/
NAVAL SUPPORT ACTIVITY
ANNAPOLIS

Matthew Klimoski, P.E.

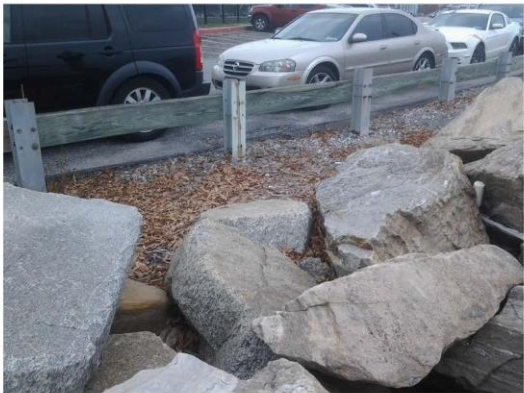
Outfall Area Photo

Outfall Assessment	
Outfall Type	Pipe
Outfall Material	Reinforced Concrete Pipe
Outfall Diameter (in)	24
Outfall Structural Condition	Normal
Type and Condition of Vegetation:	N/A
Signs of Erosion?	No

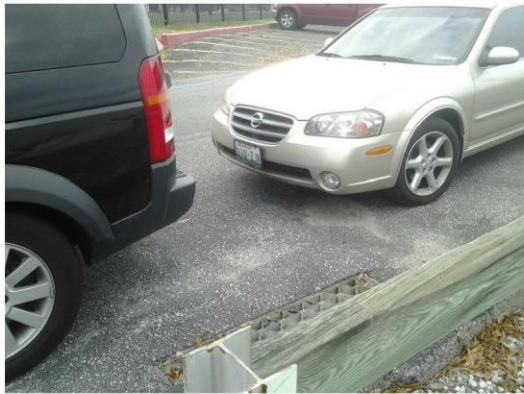
Structure 1 Area Photo

Dry Weather Flow Observed?	No Dry Weather Observed
Structure 1	
Structure 1 Type	Inlet
Asset ID of Structure 1	AP41-SD-6816
Structure 1 Material	Reinforced Concrete
Condition of Structure 1	Normal
Structure 1 Surcharged?	Yes

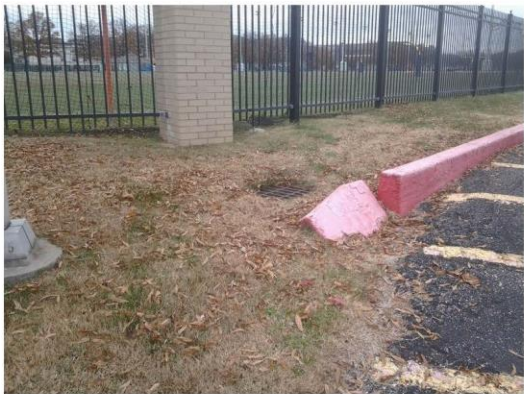
Structure 2 Area Photo

Structure 2 Dry Weather Flow?

No Dry Weather Observed

Structure 2	
Structure 2 Type	Inlet
Asset ID of Structure 2	AP41-SD-8778
Structure 2 Material	Brick
Condition of Structure 2	Normal
Structure 2 Surcharged?	No
